**Surf Rider Condominium**  
1441 S Ocean Blvd  
Pompano Beach, Florida 33062

**Milestone Inspection Report**

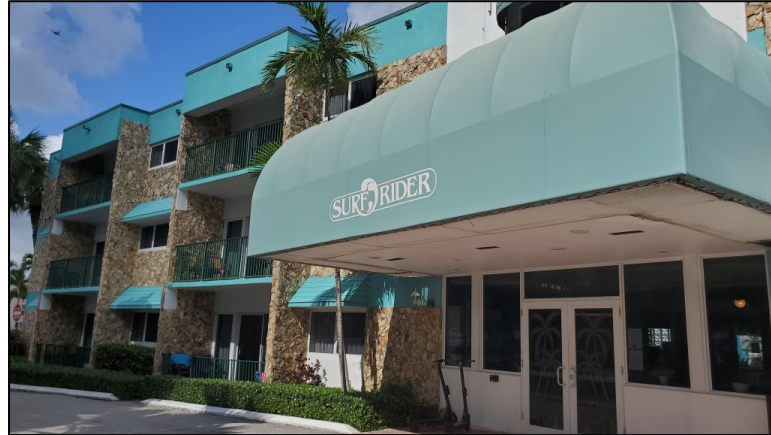
*Surf Rider Condominium*

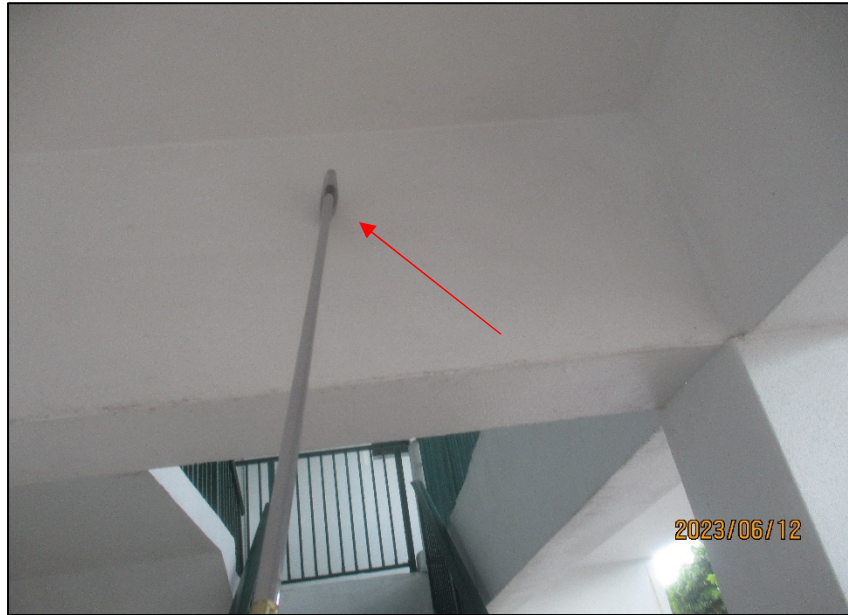
**Photograph No. IMG\_8527** – Delaminated stucco located at the beam adjacent to Unit 110 - Level 1- Building Hallways.

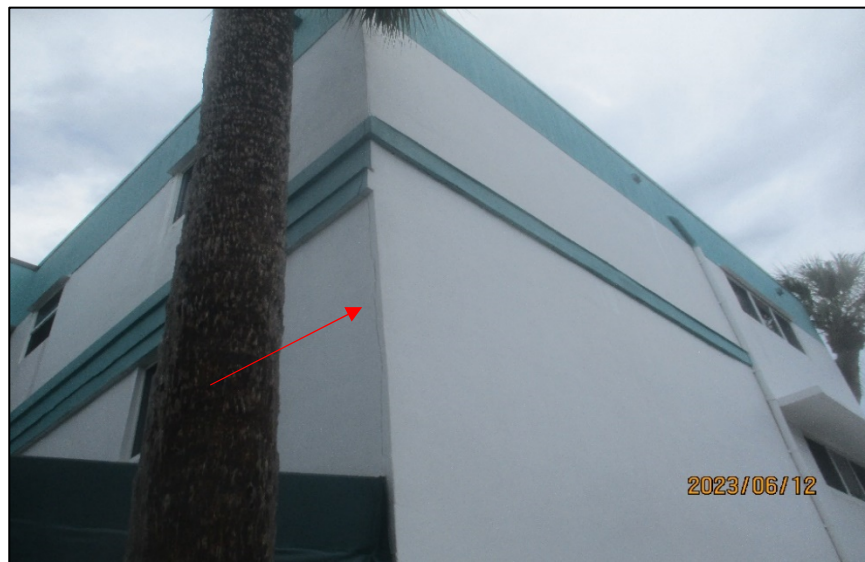
**Photograph No. IMG\_8598** – Stucco crack located at the West Elevation wall corner adjacent to the South Elevation.

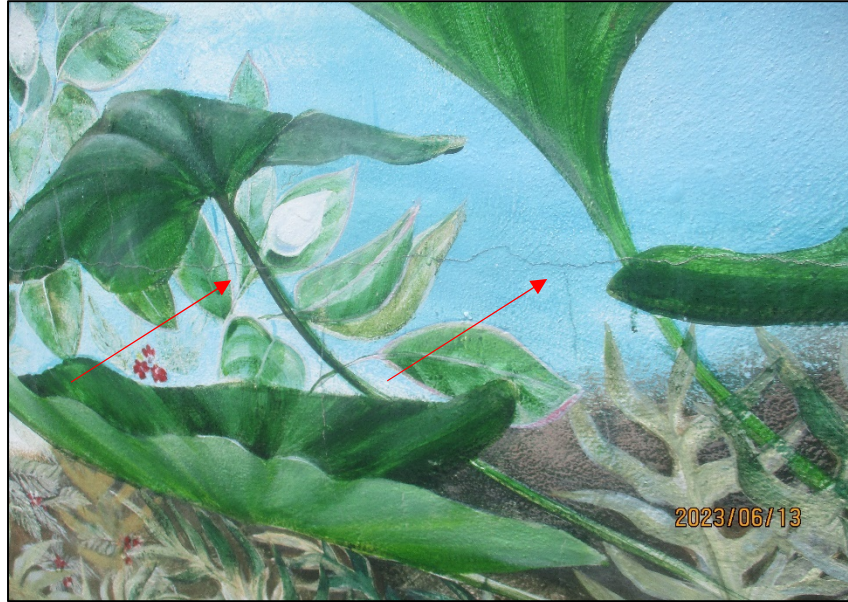
*Photograph No. IMG\_8770 – Stucco cracks located on the artistic painting wall on the South Elevation near the pool deck.*

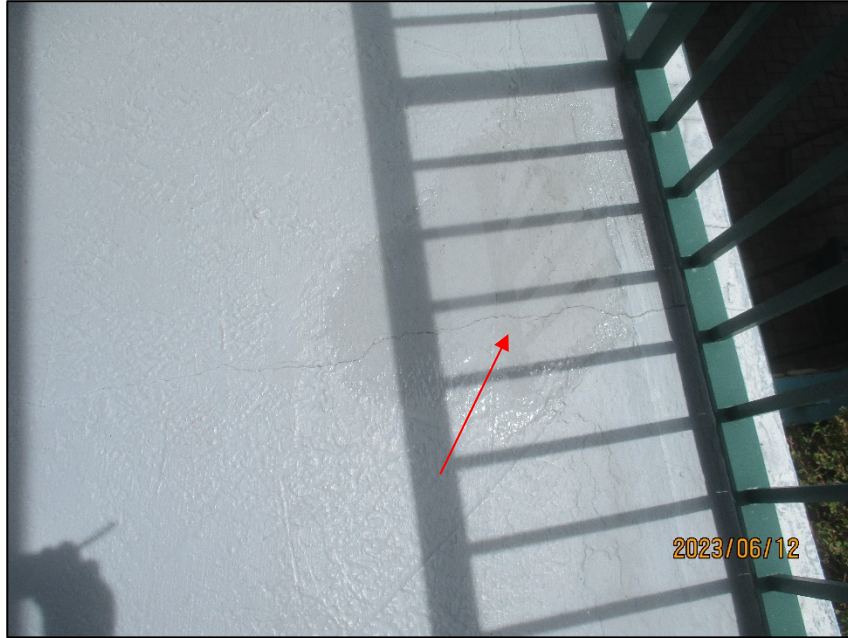
**Photograph No. IMG\_8654**– Crack in hallway floor slab in front of Unit 201 at the 2<sup>nd</sup> level.

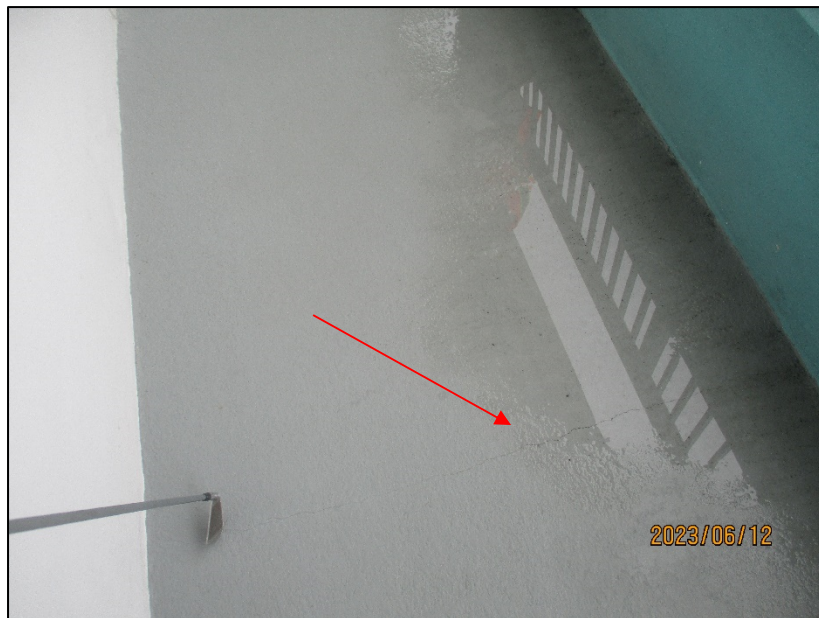
**Photograph No.IMG\_8708**– Crack in hallway floor slab in front of Unit 316 at the 3<sup>rd</sup> level.

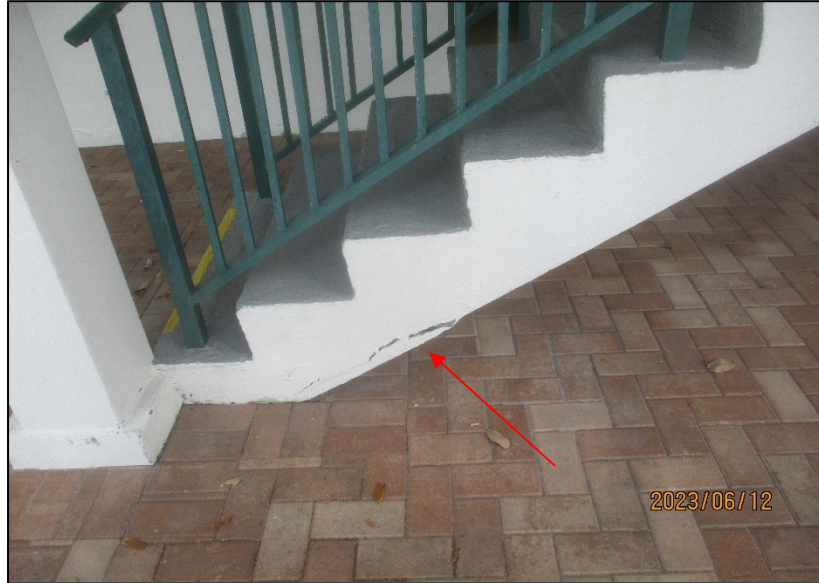
**Photograph No. IMG\_8532** – Delaminated/spalled concrete at the underside of the staircase adjacent to Unit 110 at the 1<sup>st</sup> level.

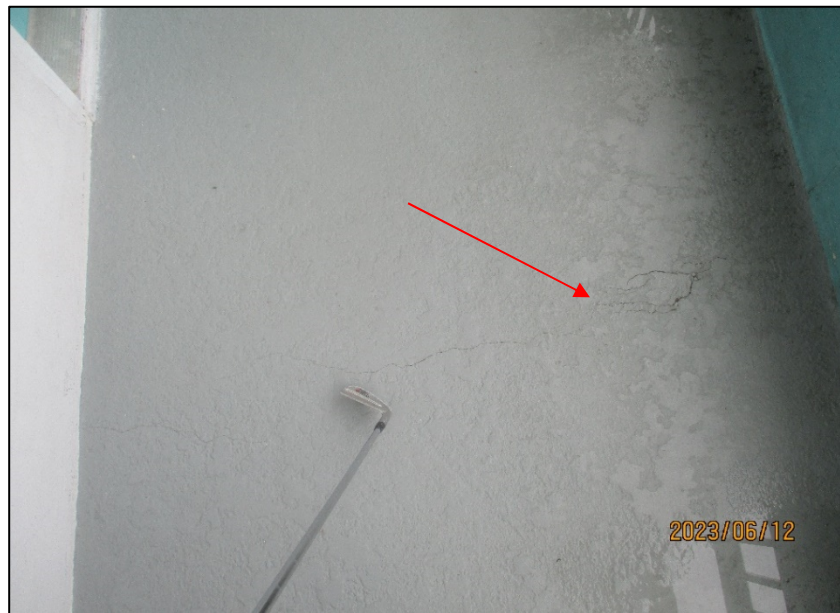
**Photograph No.IMG\_8707**– Delaminated concrete at the hallway floor slab in front of Unit 315.

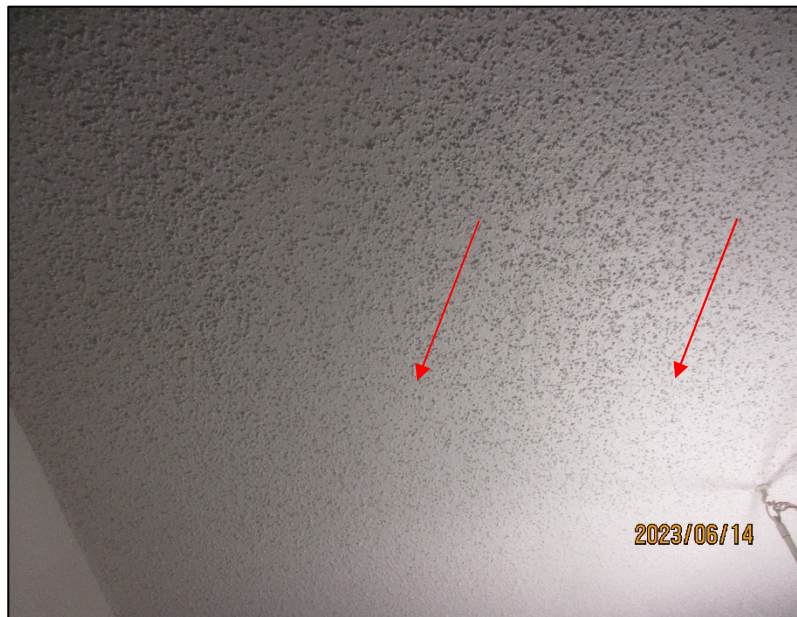
**Photograph No. IMG\_9030** – Overhead interior ceiling crack at the living room of Unit 312 on the 3<sup>rd</sup> level.

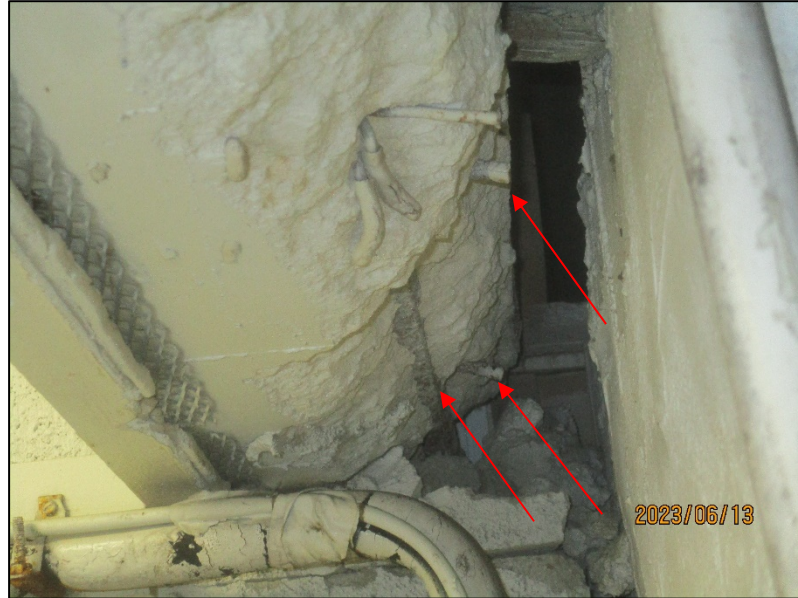
*Photograph No. IMG\_8751 – Exposed rebar at storage ceiling, located adjacent to Unit 204 at the 2<sup>nd</sup> level.*

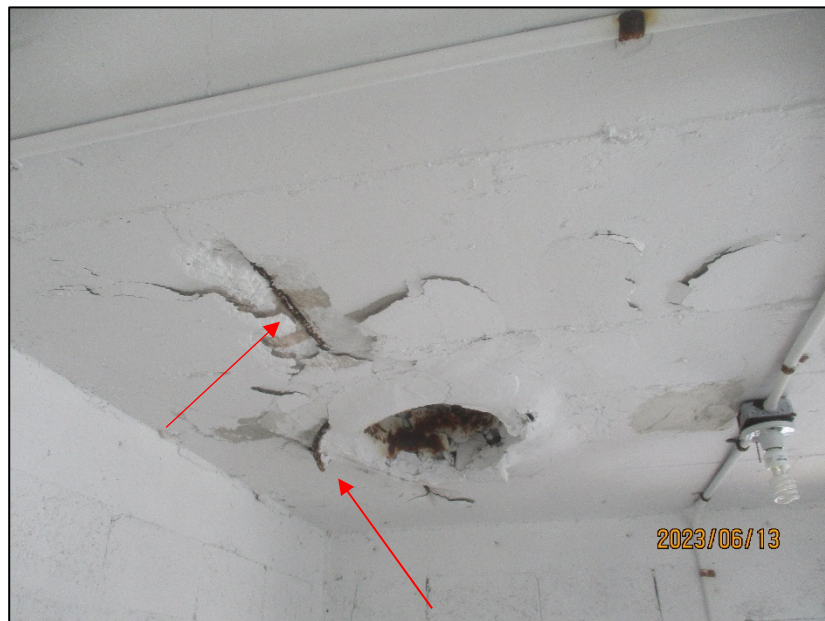
*Photograph No. IMG\_8736 – Concrete spalling/exposed rebar at the ceiling slab of the Pool Room.*

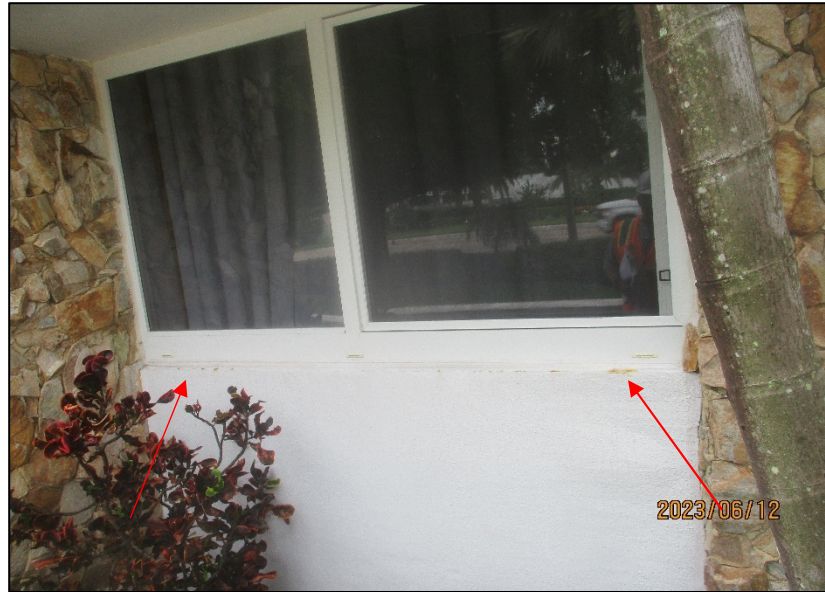
*Photograph No. IMG\_8579– Corrosion stain at the exterior window sill of the Administration Office, East Elevation.*

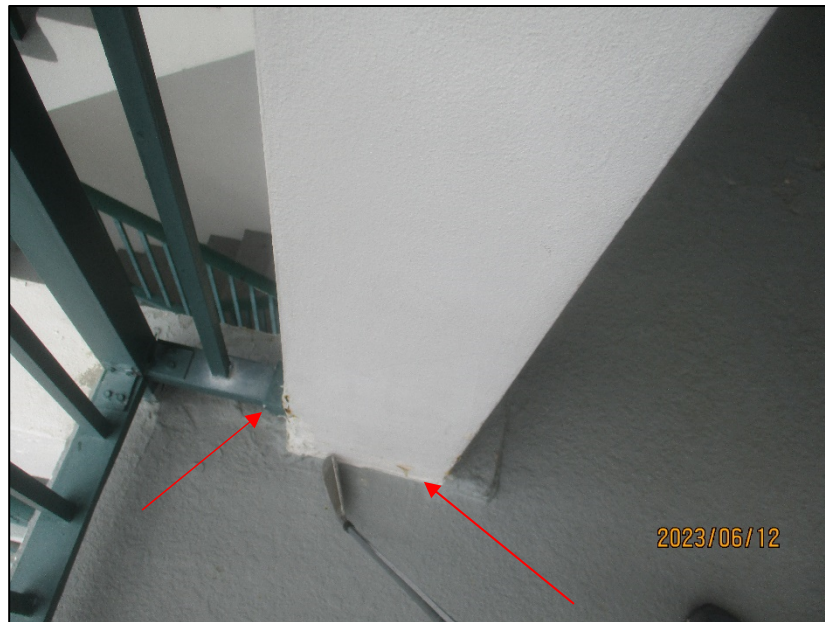
*Photograph No. IMG\_8670– Corrosion stains at the column adjacent to the stairs near Unit 303, 3<sup>rd</sup> level.*

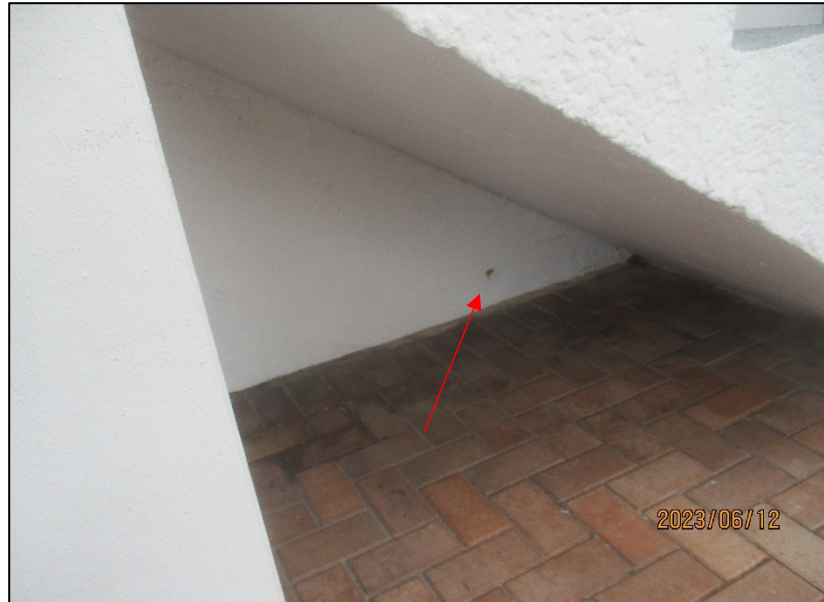
*Photograph No. IMG\_8568– Corrosion stain below the staircase that is adjacent to Unit 103.*

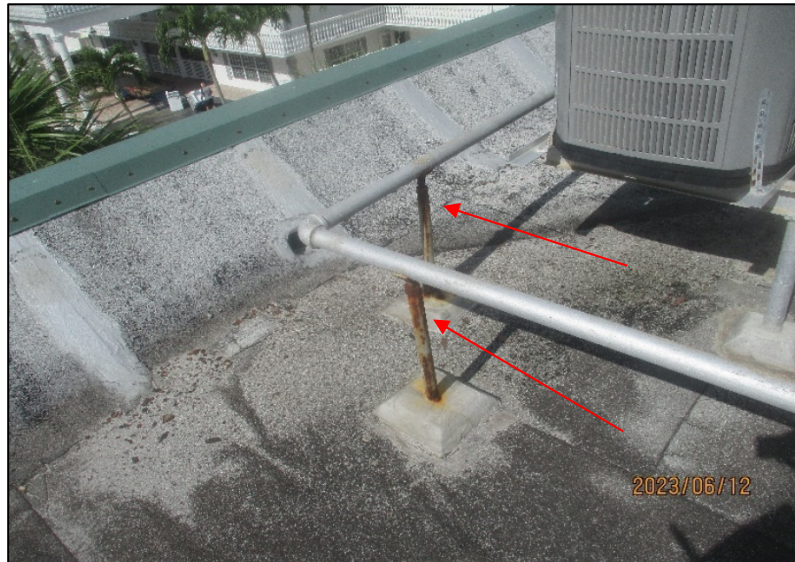
*Photograph No. IMG\_8469 – Gas pipe metallic supports are corroded at the East wing - Building Roof.*

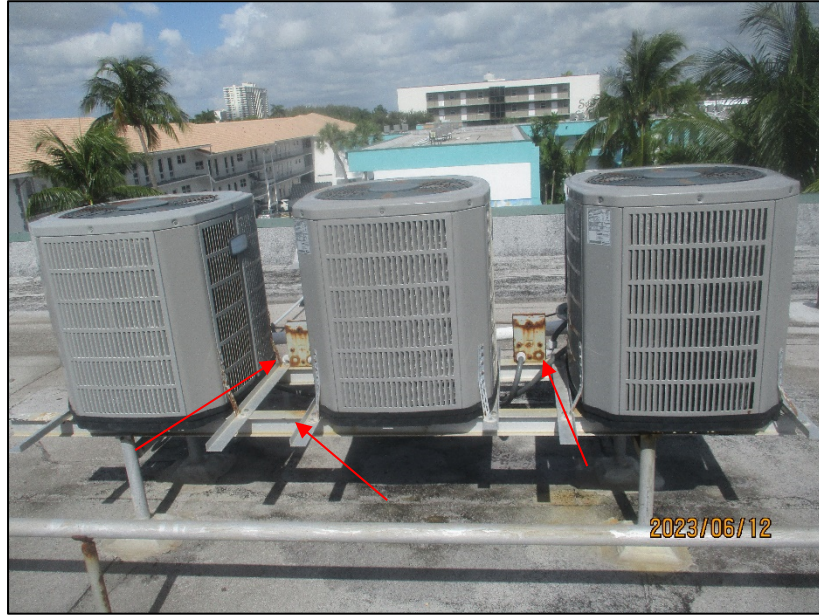
*Photograph No. IMG\_8478– Corroded metallic components of the A/C equipment - Building Roof.*

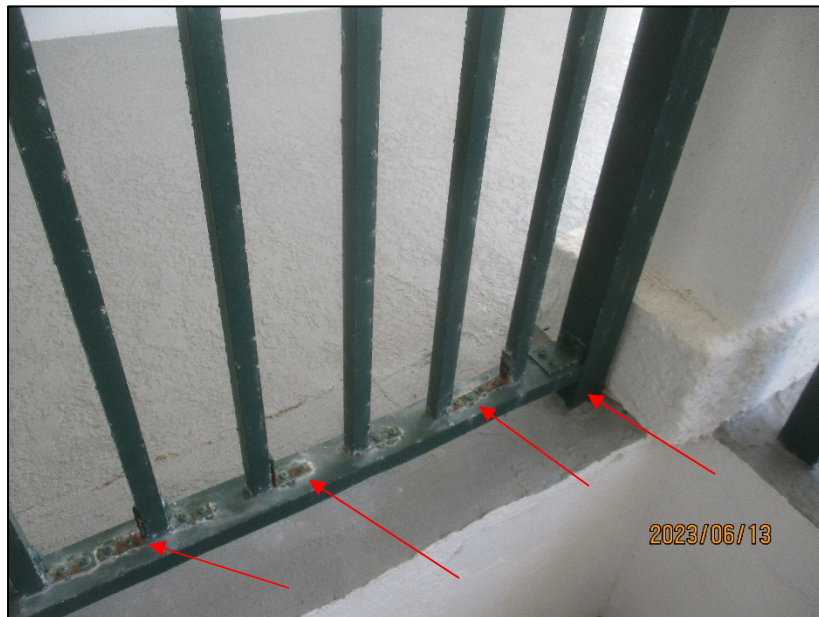
*Photograph No. IMG\_8828– Corroded screws and bolts at the staircase railings adjacent to Unit 211 – Level 2.*

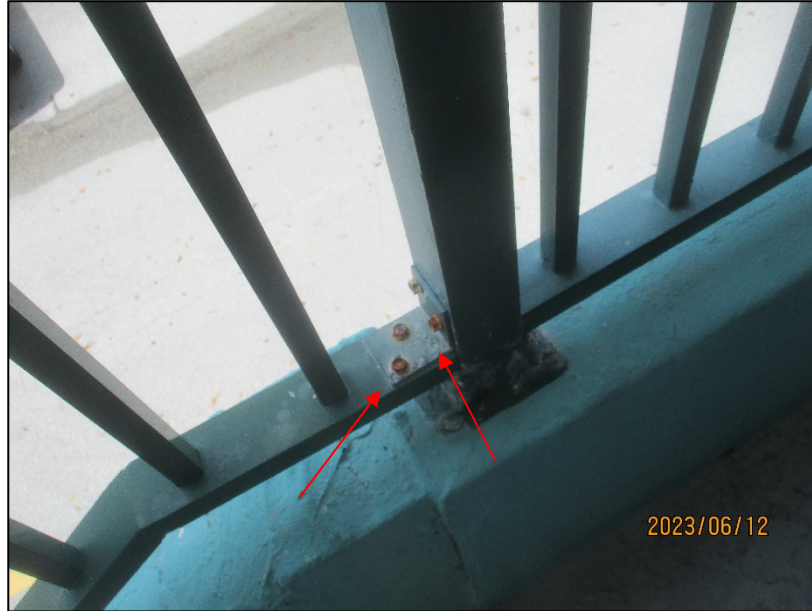
*Photograph No. IMG\_8641– Corroded metallic screws and bolts at the staircase railing adjacent to Unit 207.*

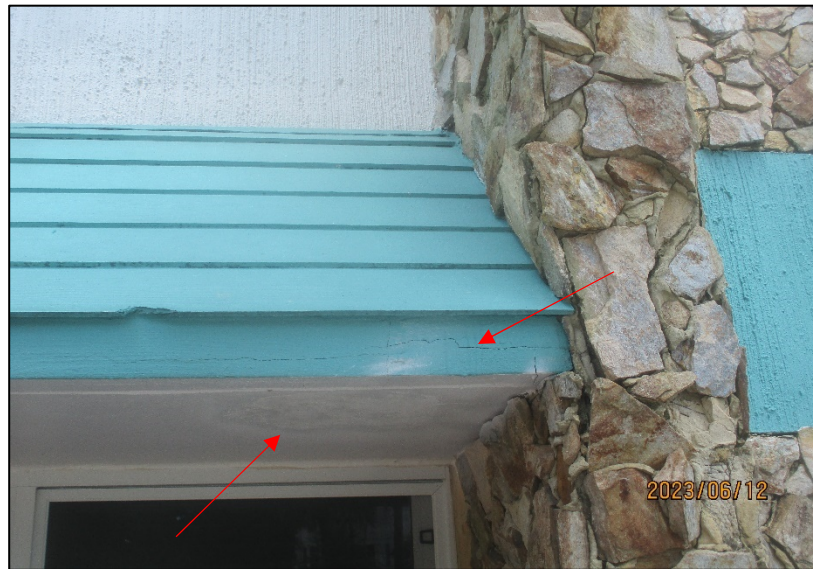
***Photograph No. IMG\_ 8576– Signs of water infiltration at the ceiling slab over the exterior window of the Administration Office – East Elevation.***

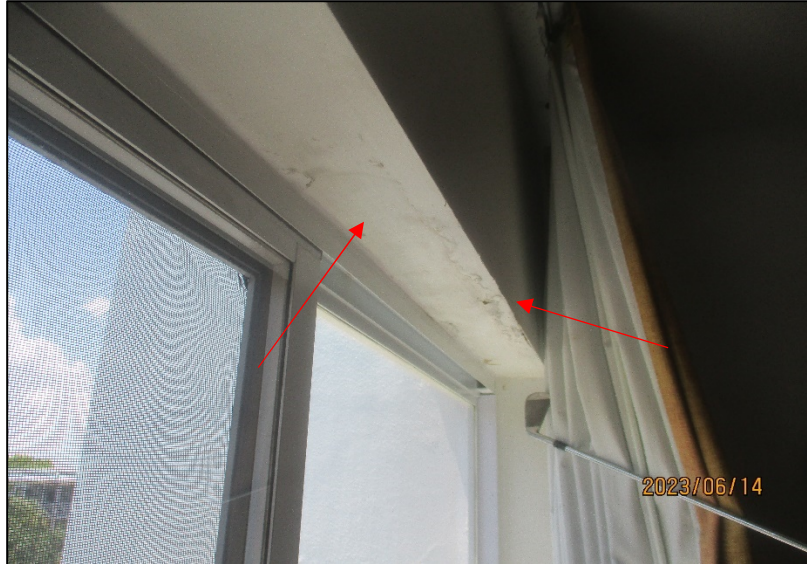
*Photograph No. IMG\_ 9035– Signs of water infiltration at the interior window in Unit 312- Level 3.*

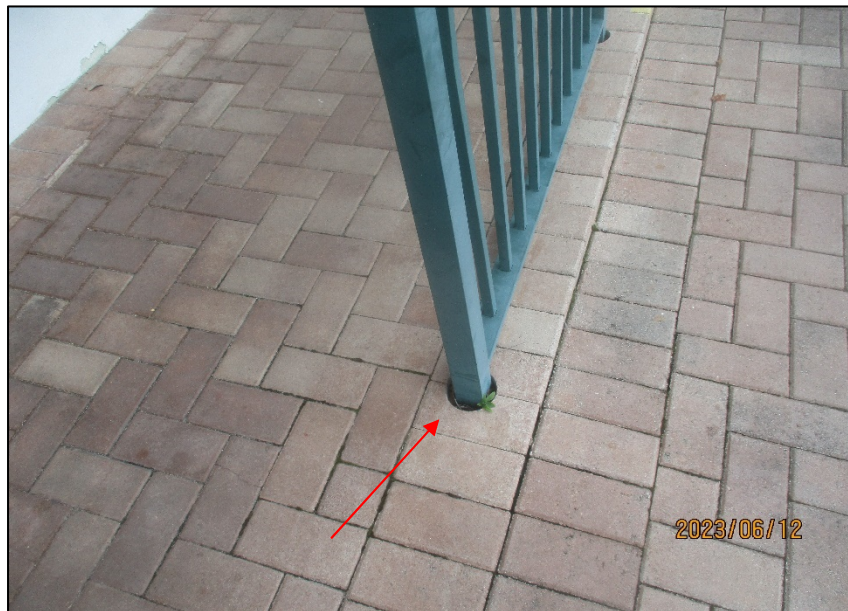
**Photograph No. IMG\_8560**– Depressed railing post pocket in front of Unit 105  
-Level 1.

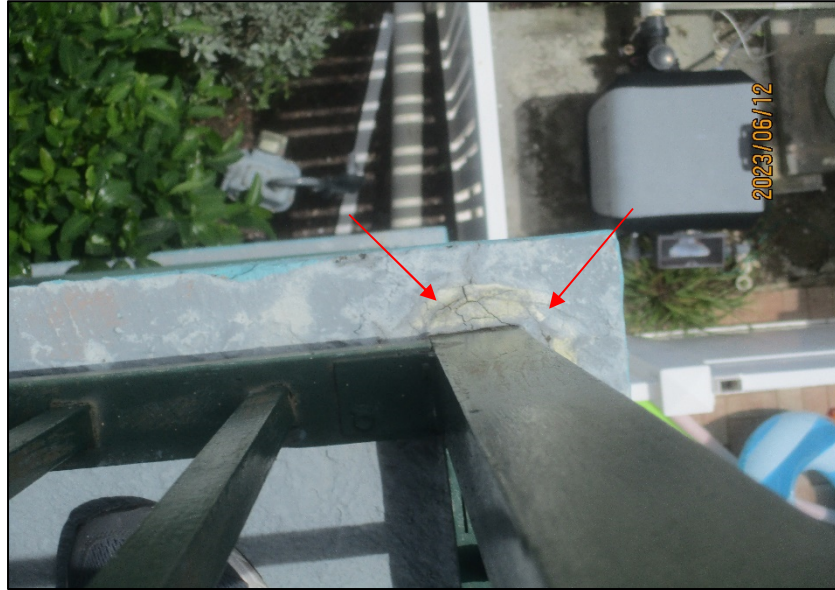
*Photograph No. IMG\_8660– Cracks in railing post pocket in landing of stairs adjacent to Unit 201.*

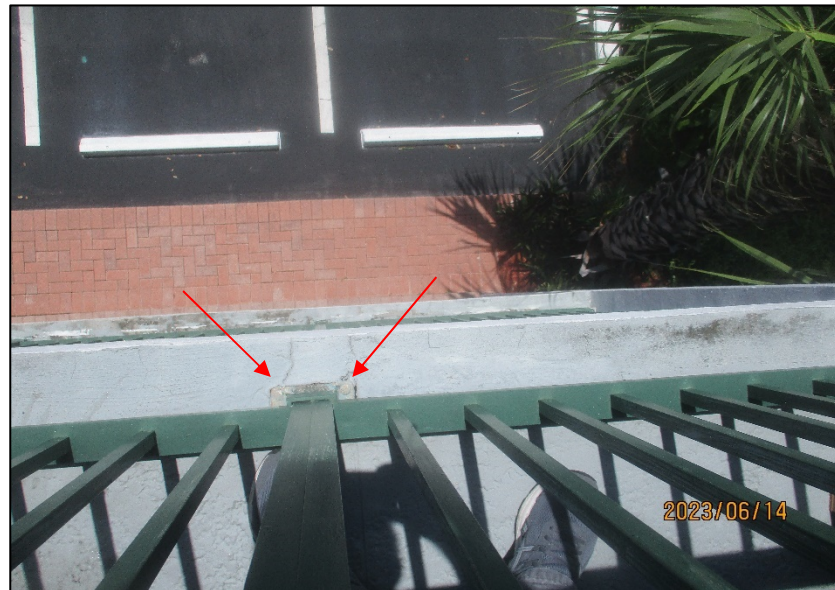
*Photograph No. IMG\_9041– Cracks in balcony railing post pocket of Unit 311 – Level 3.*

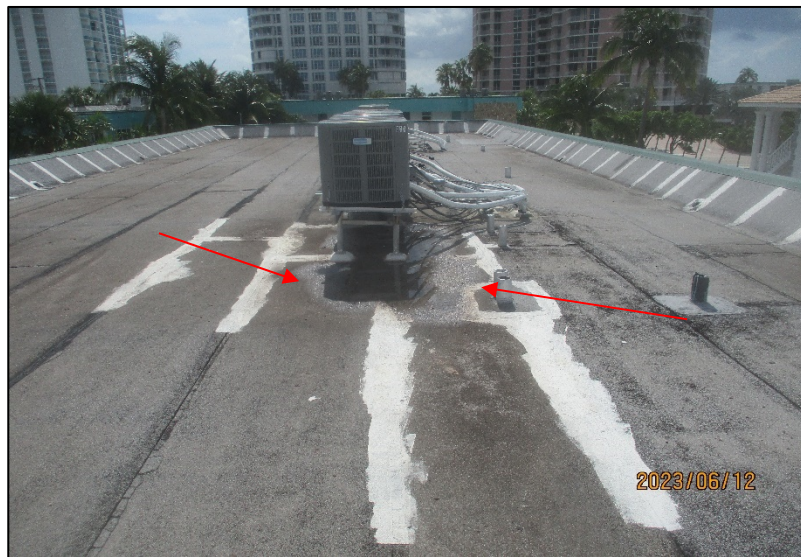
*Photograph No. IMG\_8511 – Signs of water ponding below the A/C equipment at the South wing of the building roof.*

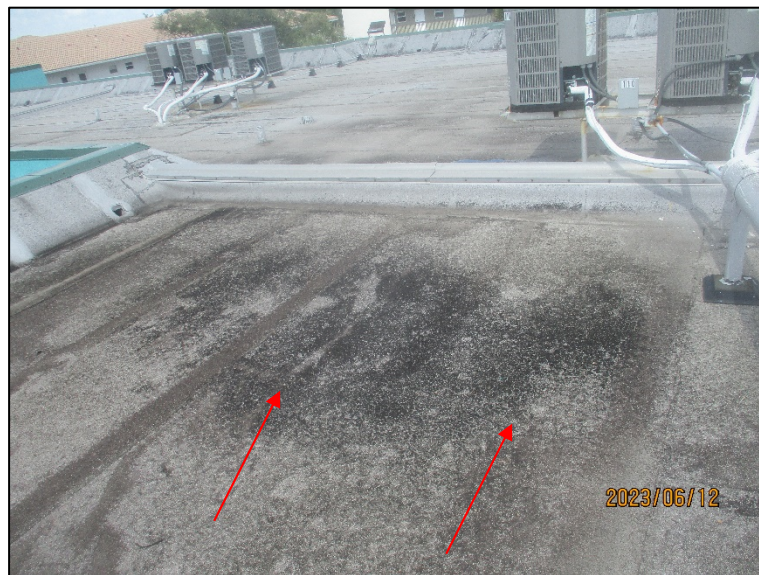
*Photograph No. IMG\_8503 – Signs of water ponding located at Southwest wing of the building roof.*

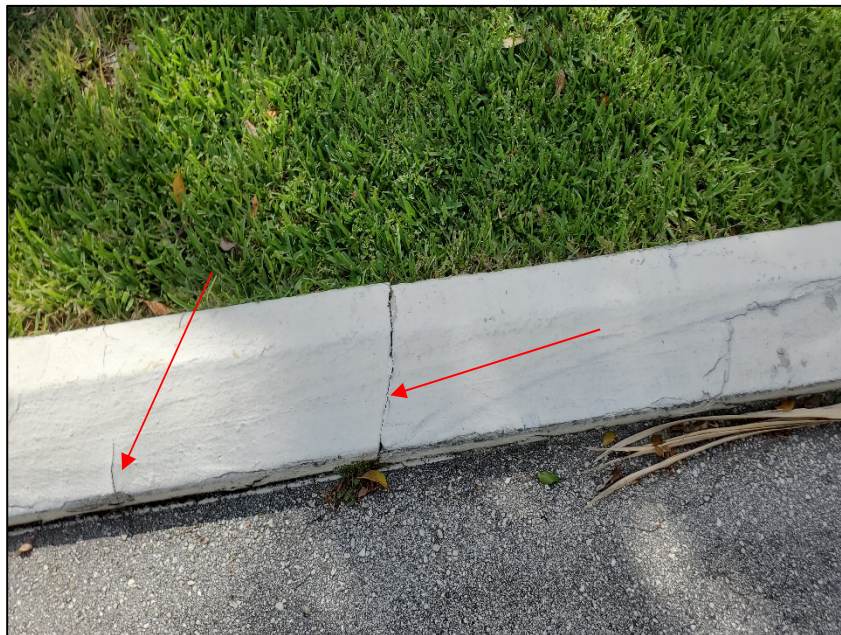
*Photograph No. IMG\_20230612-100939– Cracks in the concrete curb located adjacent to the planter in front of the main entrance of the building.*

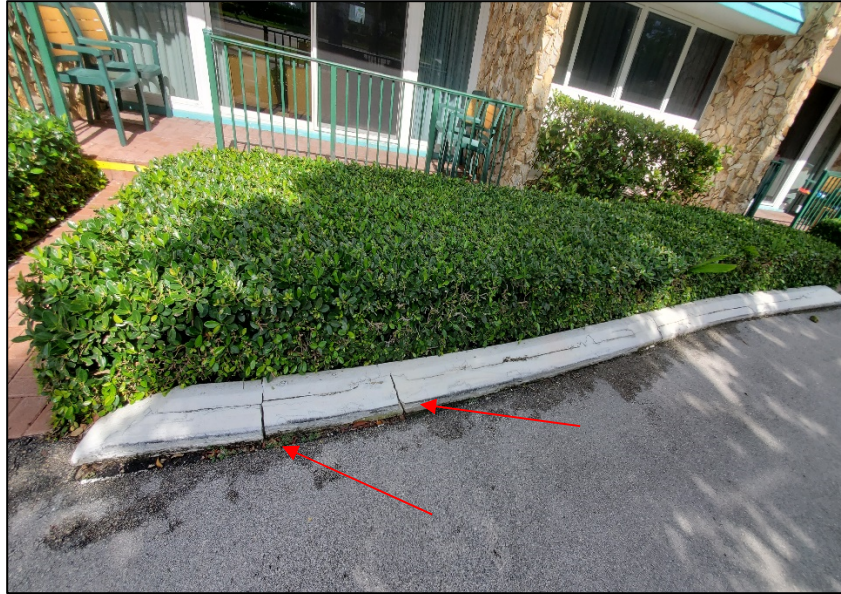
*Photograph No. IMG\_20230612-101541– Multiple cracks/debonded concrete in the concrete curb in front of Unit 101 – East side of the building.*

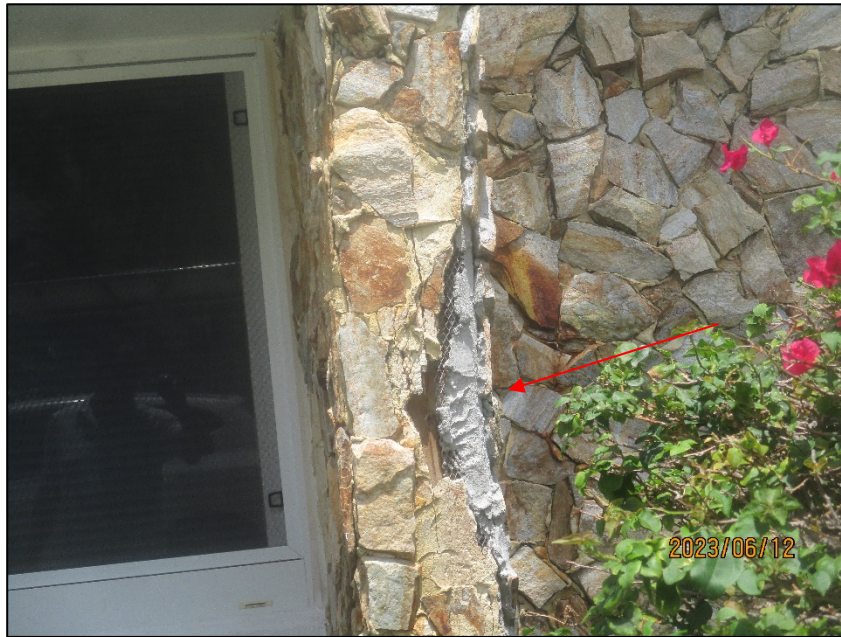
*Photograph No. IMG\_8573– Missing stone finishes adjacent to the Administration office window, East Elevation – Level 1.*

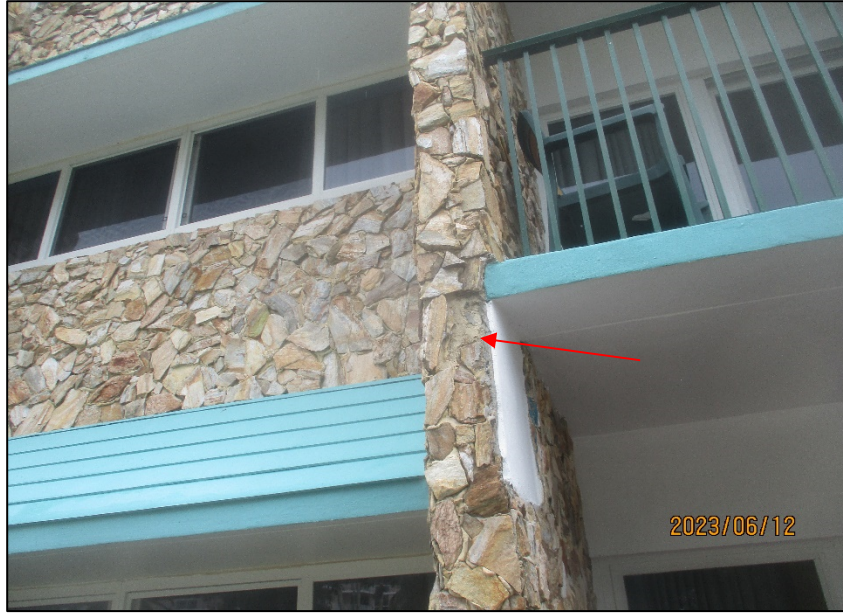
*Photograph No. IMG\_8580– Missing stone finishes adjacent to Unit 102, East Elevation – Level 1.*

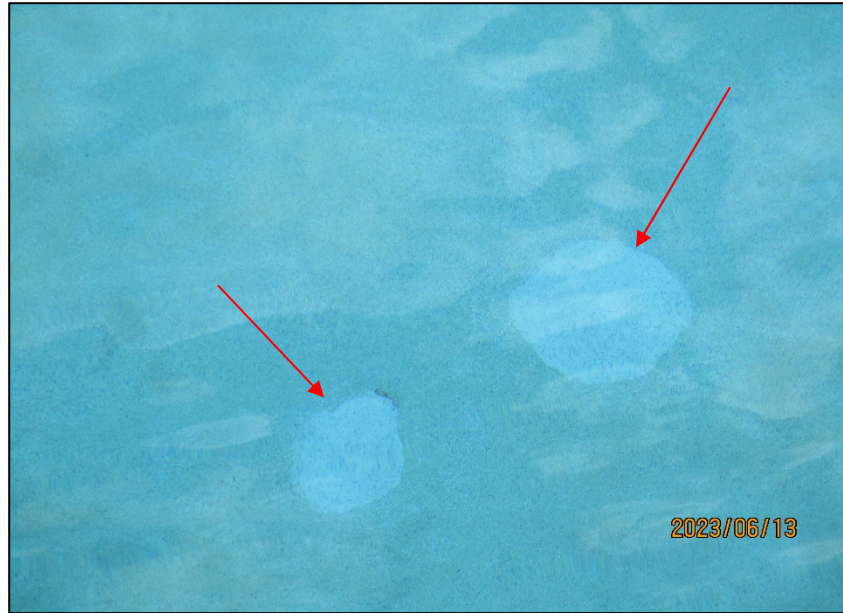
*Photograph No. IMG\_8776– Missing finishes at South side of the Pool near the white fence.*

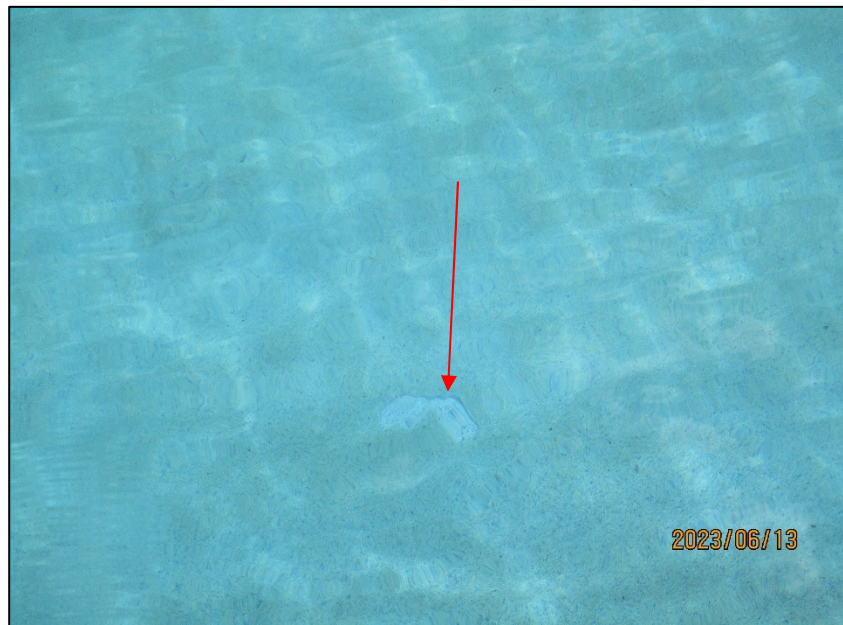
*Photograph No. IMG\_8777– Missing finishes at North side of the Pool near the pool stairs.*
